Concrete Cancer (Concrete Degradation)

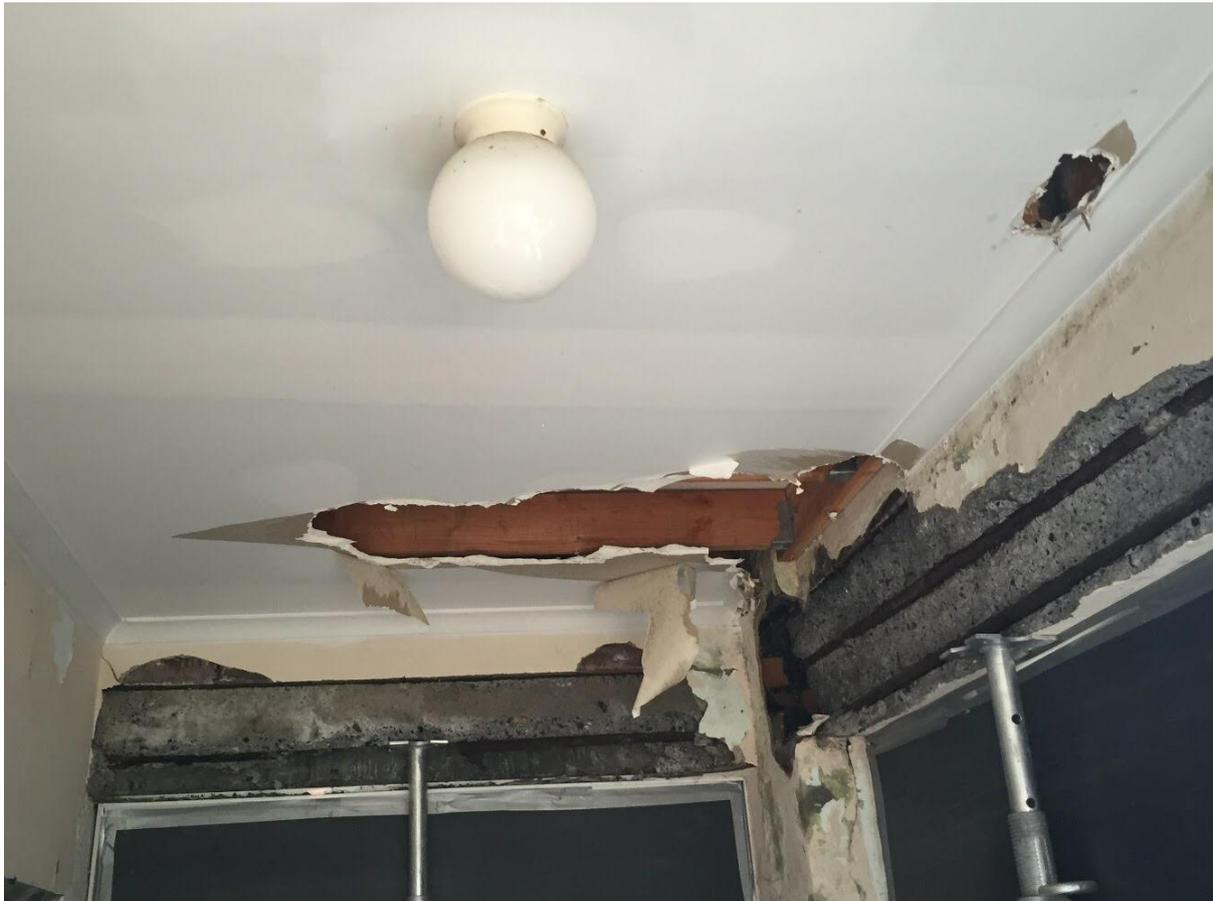
Concrete Cancer, often identified by flaking concrete or rust stains which originate deep within the concrete is a serious problem caused by rusted reinforcing from within the steel. As steel rusts, it can expand up to 7 times its original size causing the surrounding concrete to be displaced. As the steel pushes the concrete away, more water gets to the steel expediting the process.
